BACKGROUND

The test pit was positioned against the building called Simons Sundial Cottage, Grid Ref SD 76833 16013, in order to try and provide dating evidence for the building. The excavation took place on the 13th February 2016.

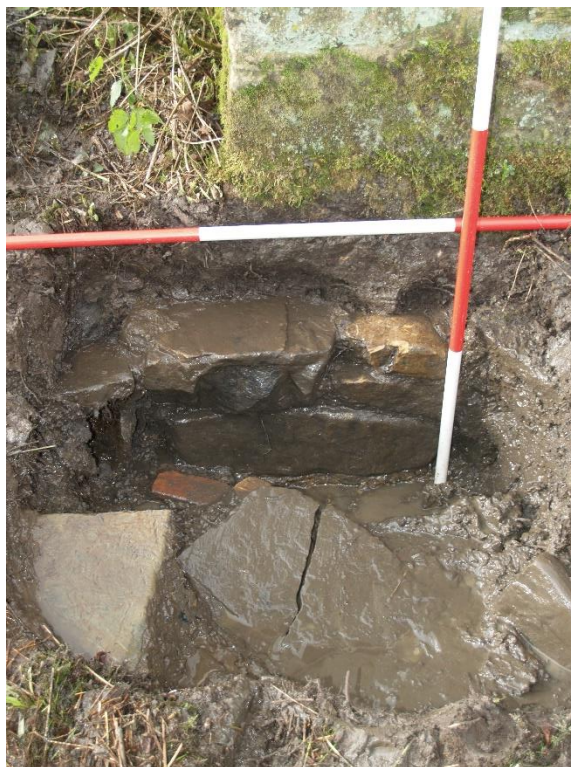
Foundation and drain cap stone, showing brick and ceramic wall for drain

The area was a mix of loam and stone rubble and was extremely wet and boggy which made for very difficult excavation conditions. There was evidence of a flagstone surface around the immediate area of the Eastern wall of the building, but this was noted to be missing from the area of the test pit and may already have been removed which may have accounted for the disturbance. The disturbed nature of the fill was born out when we discovered a rough drain had been laid in running roughly South West to North East at a depth of 30cm. The width of the drain cap stones was roughly 30cm as far as could be ascertained given the conditions. The drain itself had been very roughly constructed using bricks and reused pieces of ceramic blocks, possibly from an old sink / basin, and had a flagstone top. The drain appeared to be sat on natural clay.

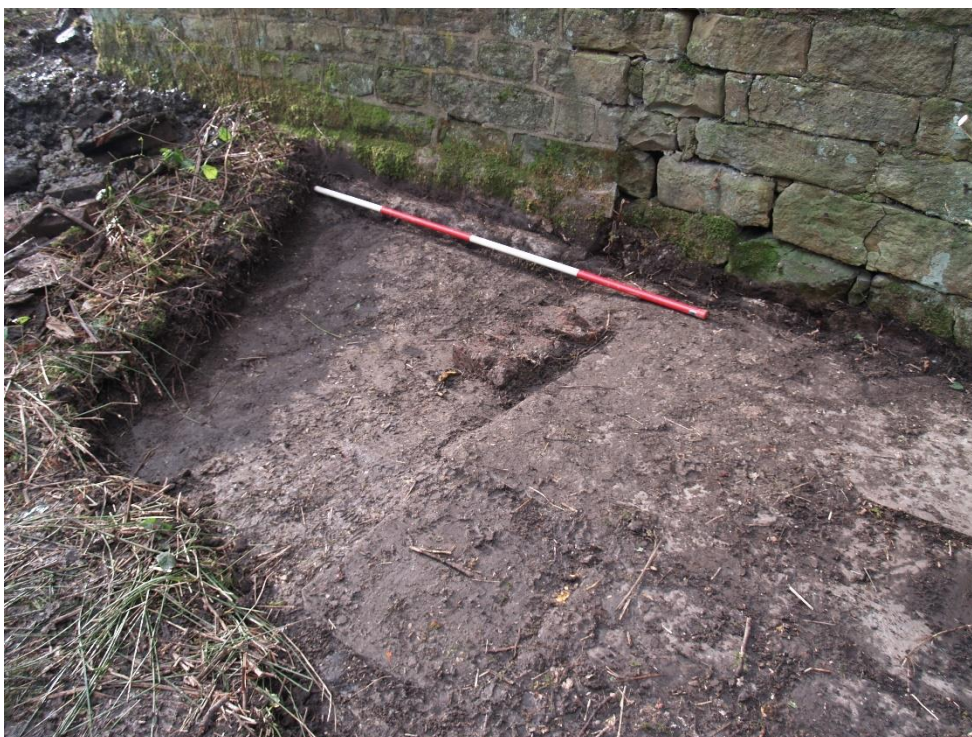
Showing flagstone surface by the side of the test pit

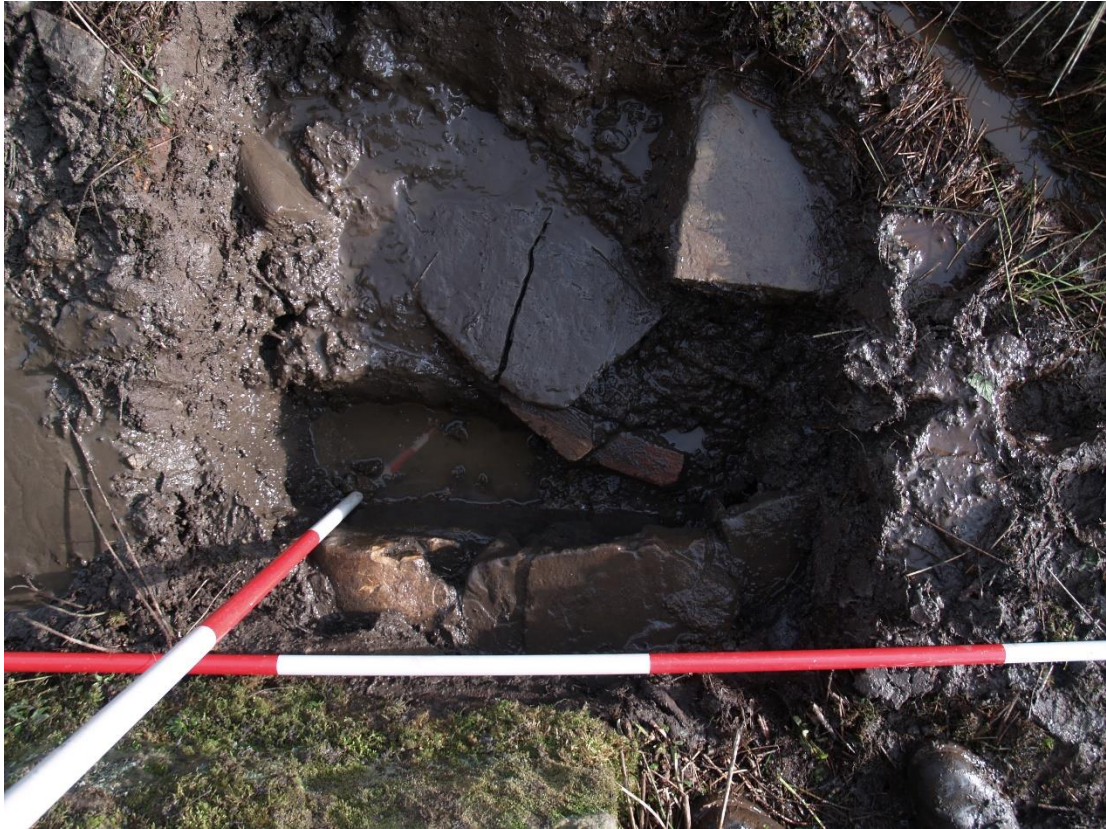
Looking down into the test pit and showing the drain and wall foundation

The foundation for the building was stepped out from the building line by 20cm and this was also visibly the case for the return on the Southern wall too. The depth to the base of the foundation from the ground surface was 60cm down to the natural clay and gravel. The depth from the ground surface to the top of the step in the foundation was 22cm and then 38cm down to the natural clay. The corner stone at the base of the foundation measured 60cm long x 20cm deep. The foundation was constructed of a rough undressed stone and in the corner was two courses deep.
